# NEW AND ALTERNATIVE BARRIER SYSTEMS – INVENTION, APPROVAL, REALIZATION AND QUALITY ASSURANCE STANDARDS DURING CONSTRUCTION

A. WITZSCHE AND J. WEIß \*

*\* CDM Smith Consult GmbH, Neue Bergstraße 13, 64665 Alsbach, Germany*

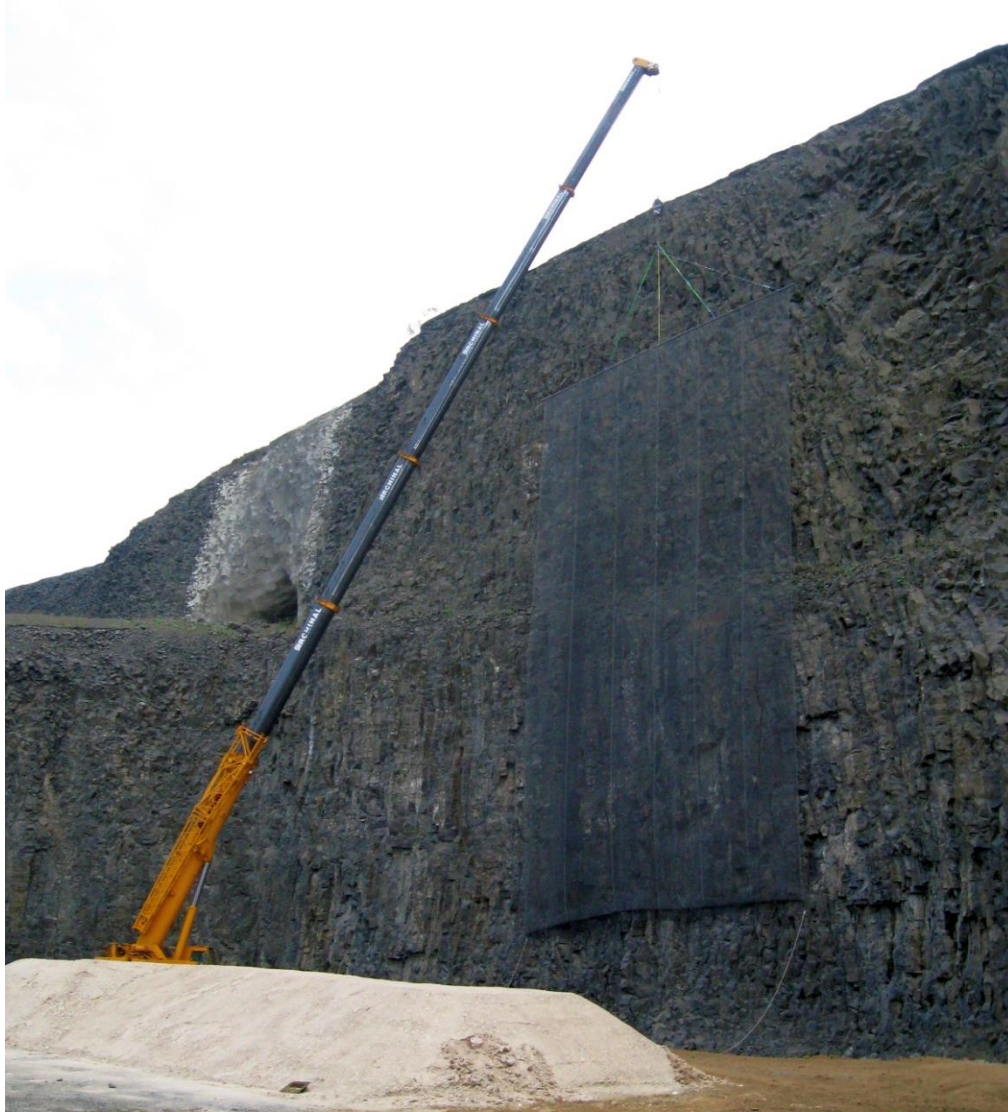
Figure 3. Rock Wall in the South of the Landfill

Great importance was also attached to health and safety measures during the construction work as people had to work at the bottom of a 40 meter high rock wall, and it could never fully be ruled out that there would be no rocks falling from the upper part of the rock wall. Therefore, the building sections, in which people were working, were secured by a steel net fixed to a mobile crane. Falling rocks were retained by the net and thus a maximum degree of safety was achieved for the people working right on the wall (see Figure 3). As a consequence, people were only able to work in a small strip beneath the net.

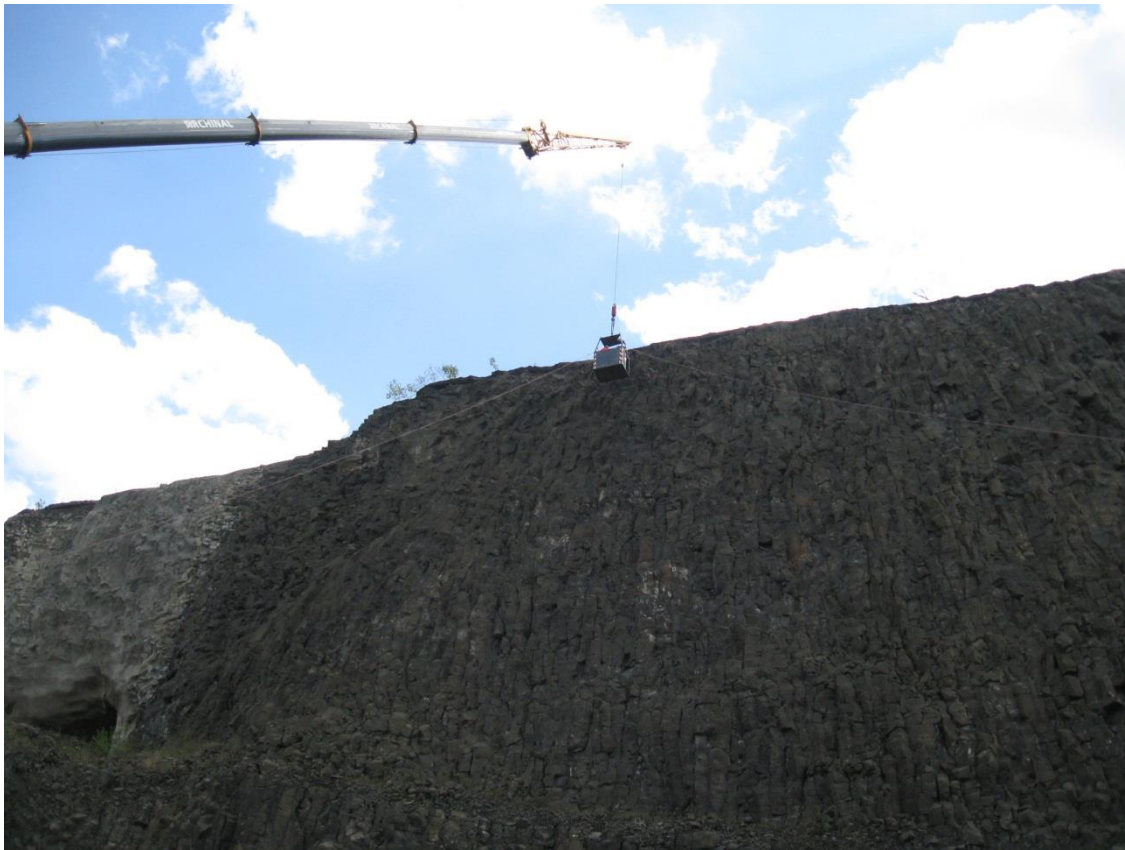
In order to remove the loose rocks, the construction supervisor and the external monitors used a mobile crane in order to examine the wall.

Figure 6. Inspections Along the Rock Wall

The loose rocks were documented for removal. Loose rocks, which could not be cleared out because of their size and location in the wall were fixated into position with air-placed concrete. Also open cavities were closed using air-placed concrete. The inspection of the wall was then carried out visually. In addition, the results of the secured wall were documented.
