Appendix H

LITERATURE OVERVIEW OF STURGEON MIGRATION BEHAVIOUR AND ANALYSES OF CURRENT LEGISLATIVE FRAMEWORK IN RELEVANT ICPDR COUNTRIES INCLUDING MULTILATERAL ENVIRONMENTAL AGREEMENTS WITHIN THE SCOPE OF WE PASS

Date: 12th November 2021

Author: Dr. Mirjana Lenhardt, Institute for Multidisciplinary Research University of Belgrade

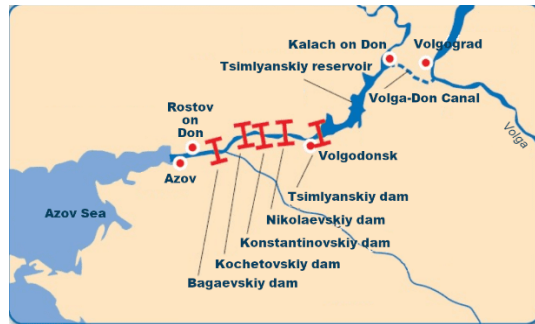
Figure 3: Bagaevskiy rkm 95, Kochetovskiy rkm 179, Konstantinovskiy rkm 212, Nikolaevskiy rkm 251 and Tsimlyanskij dam rkm 309 on the Don River (From article in journal "Mir Novostey" 30/10/2018)

The main problem for navigation on the River Don is still the low water level in the lower part of the river. This was the reason why construction of a new dam, the Bagaevskiy dam, was initiated in April 2018, downstream of the Kochetovskiy dam, to enable safe navigation on the river (Fig 3).

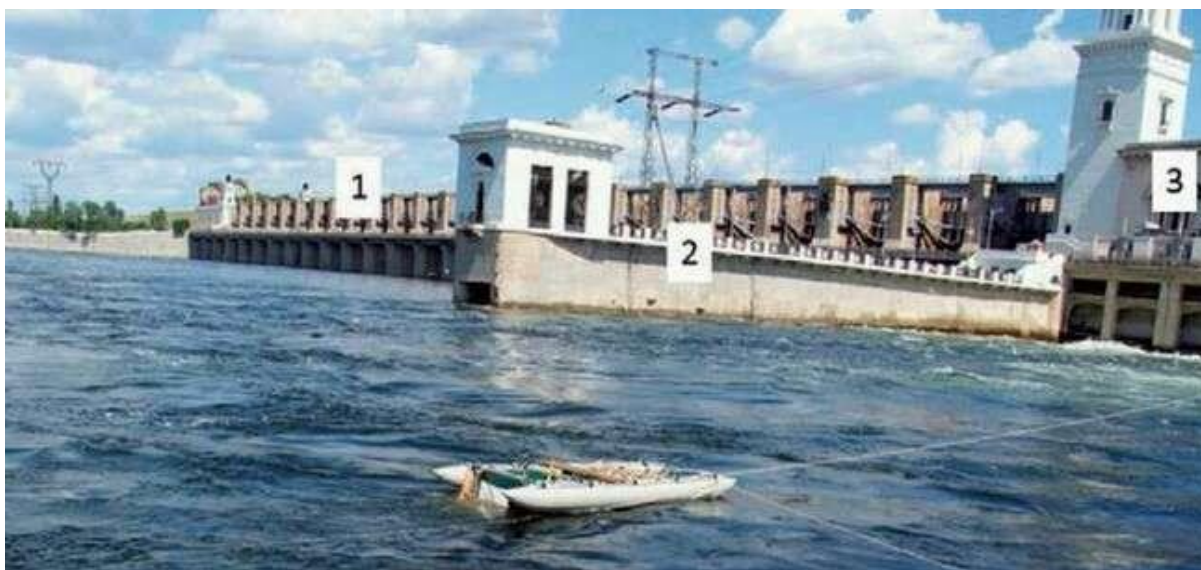
Figure 8: Tsimlyanskiy dam on the Don River. 1 – overflow dam; 2 – fish lift (trapping pool); 3 – powerplant (From Pavlov and Skorobogatov 2014)

It is constructed for sturgeon, shads and vimba bream; however, sturgeons were recorded mainly during the first 8 years of operation until 1964 when sterlet passage reached 2,200 specimens per year (Pavlov and Skorobogatov 2014). At present, 23 fish species have been recorded using the fish lift, including sterlet.

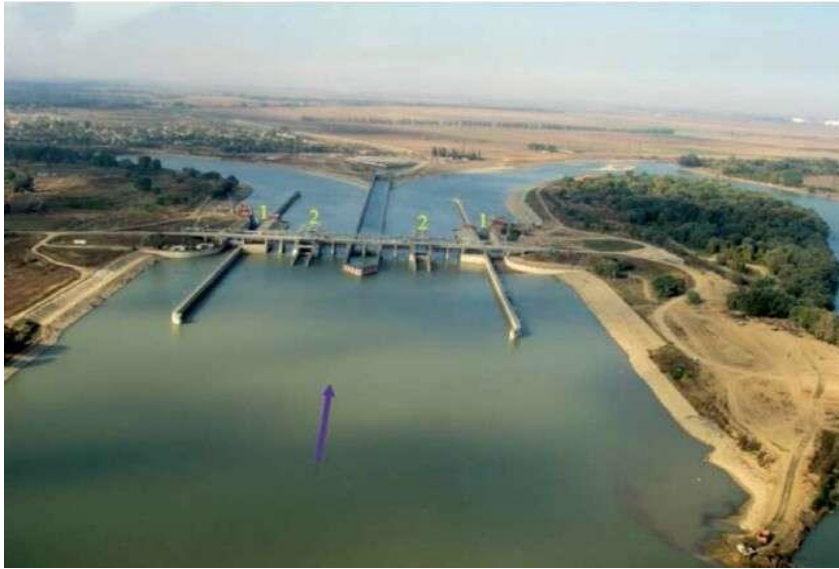
Figure 9: Tikhovskiy dam with fish locks. 1 – ship locks; 2 – fish locks (From Pavlov and Skorobogatov 2014)

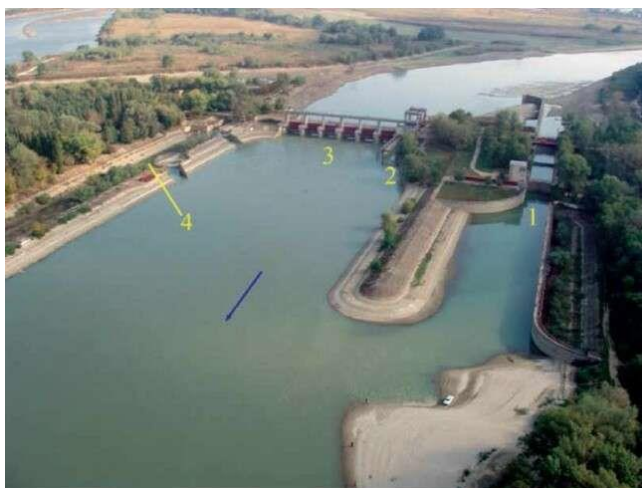
Figure 10: Fedorovskiy dam on the Kuban River. 1 – ship lock; 2 – fish lock; 3 – spillway; 4 – technical passage Soldatov (From Pavlov and Skorobogatov 2014)

One fish lock and one technical passage were built for fish to pass. A technical passage (Soldatov) was built in 1967 (Figure 10). This technical fish passage had length 275 m, width 10 m and seven steps (length 12 m; difference between levels 0.8 m). During 15 years of work (1967-1982) there was no records of sturgeon passage. The attraction flow which was close to the threshold (~ 0.2 m/s) was the main reason for the failure of this fish passage on the Fedorovskiy dam (Palov and Skorobogatov 2014). Sturgeon passage through the Fedorovskiy Dam was possible only 21 years

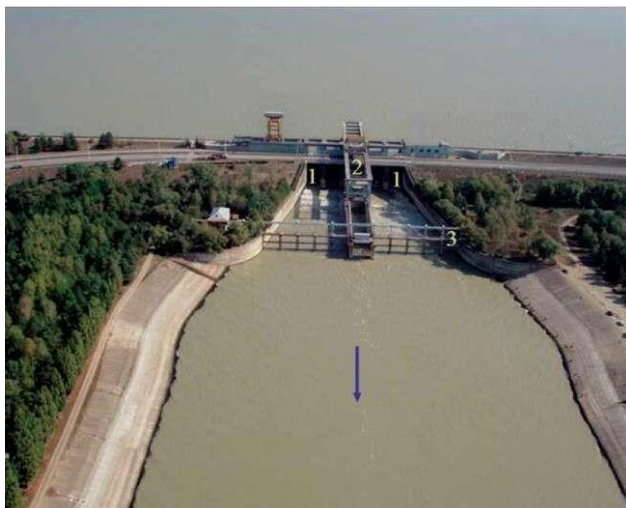
Figure 11: The Krasnodarskiy dam on the Kuban River. 1 – spillway; 2 – mechanical fish lift; 3 – electric barrier for fish (From Pavlov and Skorobogatov 2014)

There is an electric barrier for fish near the entrance to the fish passage (Figure 11). After 30 years of exploitation, the fish lift was repaired in 2013-2014. Hydraulic investigations showed that it is possible to produce the necessary attraction flow (0.6-1.4 m/s) at the entrance to the fish passage, but there are considerable differences in the water velocities in the downstream chamber, as well as turbulence, and it is thought that the downstream chamber should be 30-40 m longer (Pavlov and Skorobogatov 2014). Investigations also showed that after 30 years of exploitation of the Krasnodarskiy dam, the observed hydraulic conditions in the tailrace were the result of changes in the bottom topography.

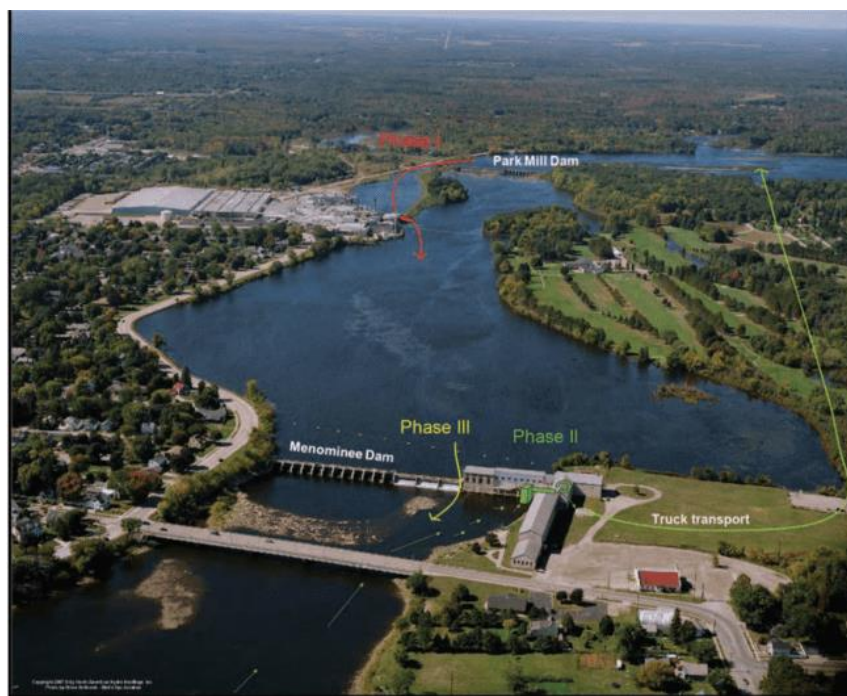
Figure 15: Menominee and Park Mill Dam sturgeon passage facilities (truck transport upstream of the Park Mill dam). Phase I, downstream passage at Park Mill was constructed in 2013-2014 and completed in January 2015; Phase II, an upstream elevator and sorting facility at Menominee was constructed in 2014-2015 and placed in service in 2016; Phase III, the downstream passage at Menominee was constructed in 2016 and began operating in 2017; The upstream pointed arrows denote the upstream migration/movement of lake sturgeon. Photo credit: Eagle Creek Renewable Energy

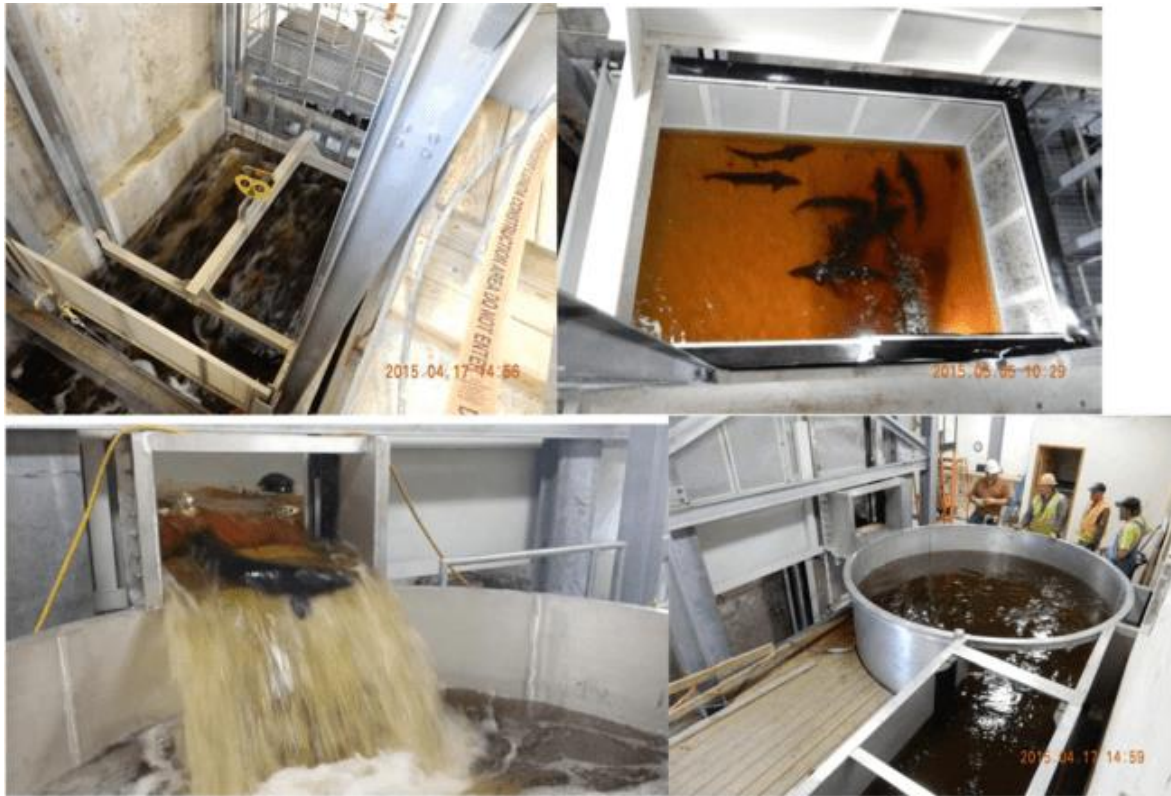
Figure 16: Upstream fish lift and sorting facility. Photo credits: Rob Elliott, U.S. Fish and Wildlife Service

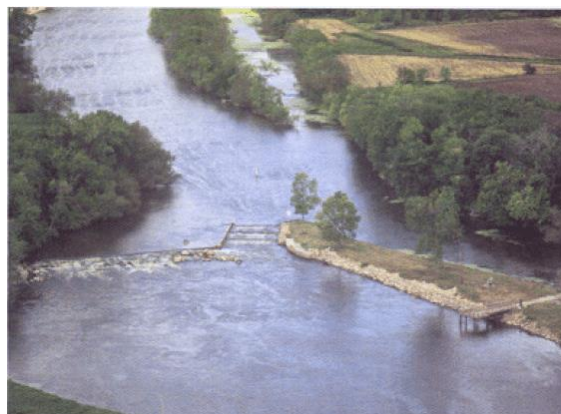
Figure 18: The Eureka Rapids and fish passage on the Eureka dam (From Bruch 2008)

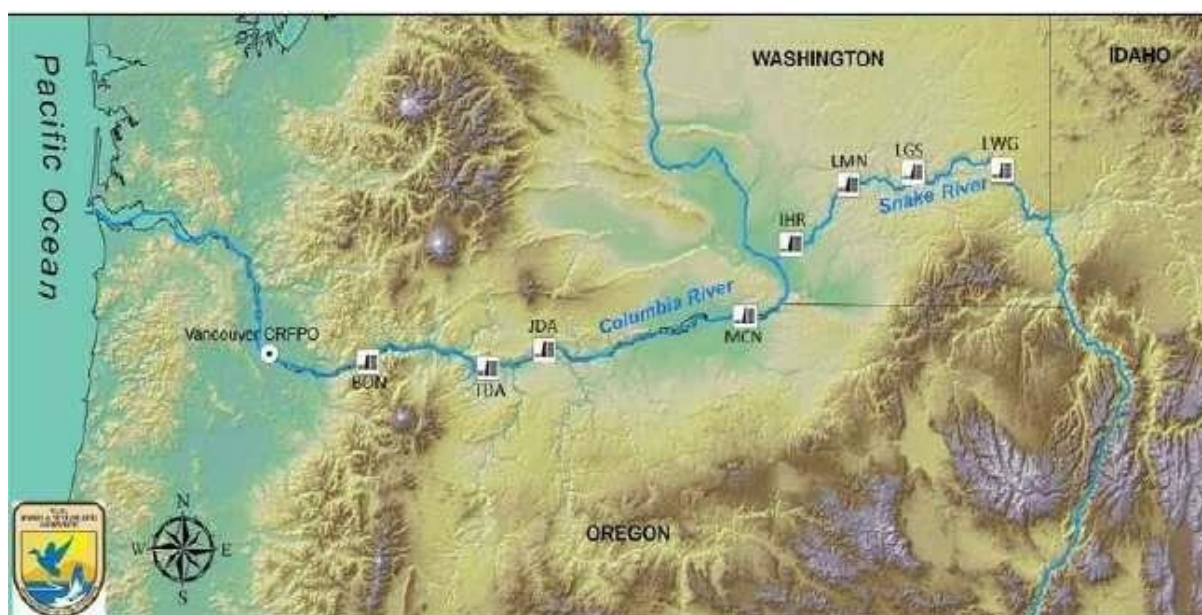
Figure 23: Lower Columbia River with the Bonneville (BON), Dalles (TDA) and John Day (JDA) dams (Wills 2014)

The Columbia River, with a length of 2,000 km, is the fourth largest river in the US by volume with the greatest flow of any North American river entering the Pacific. Construction of hydroelectric dams on the Columbia River highly impacted white sturgeon, which resulted in several individual landlocked populations. The first dam from the mouth of the Columbia River is Bonneville dam lying at 235 rkm, upstream is Dalles dam at 309 rkm, and 36 km upstream is the John Day dam located (Figure 23). The construction of dams in the Columbia River basin has

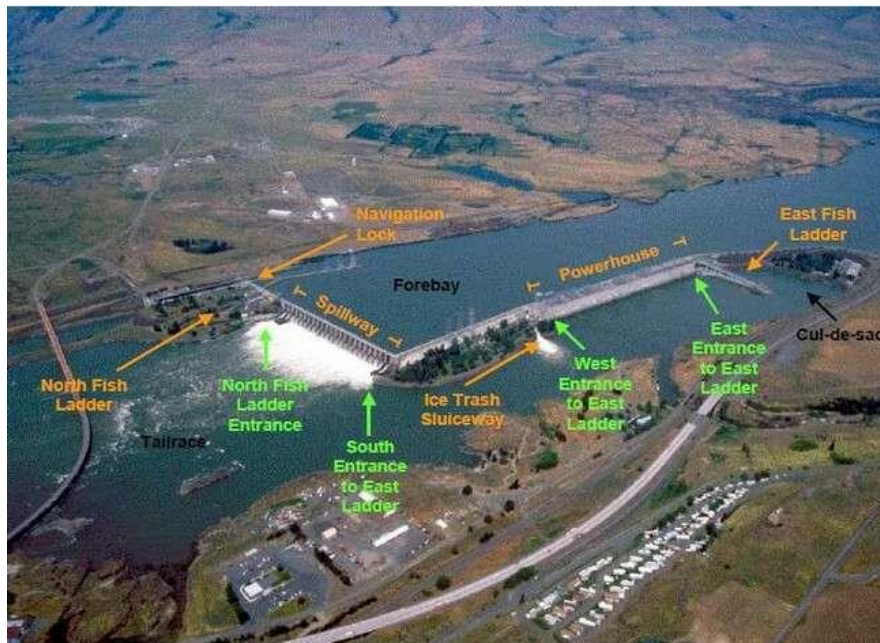
Figure 25 : The Dalles dam with north and east fish ladders (Parsley et al. 2006)

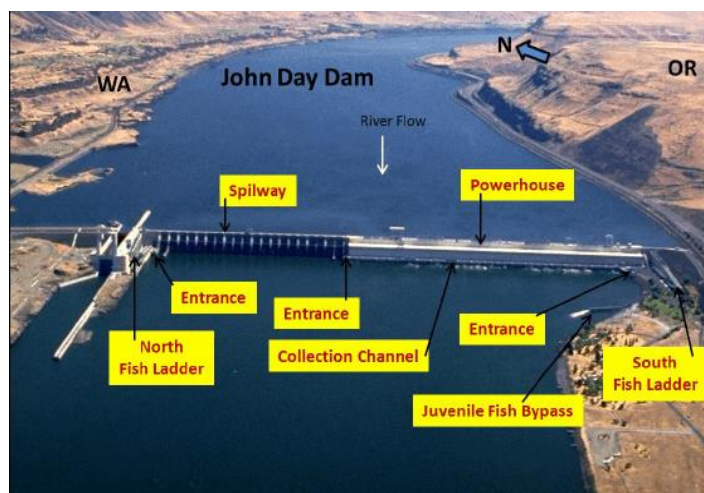
Figure 27: The John Day dam (Wills 2014)

Fish passage facilities comprise two fish ladders on the north and south side of the dam, (Figure 27). As in the case of the Bonneville and Dalles dams, anadromous salmonids were the target species for these ladders. In a typical year during the fish passage season the vertical ladder elevation change is about 30.8-31.1m that fish must negotiate. John Day Dam has entrance that lead to a powerhouse collection channel, entrance to south fish ladder and entrance to north fish ladder (Figure 27). Velocity at the entrance to powerhouse collection channel is in range 2.4-2.7 m/s as well as at the entrance of south and north fish ladder, and 0.4-1.2 m/s in the channel. South fish ladder composed of entrance, junction pool, ladder section 1, count window, ladder section 2, turning pool 1, ladder section 3, flow control and exit near the south end of the powerhouse. North fish ladder composed of entrance, ladder section 1, turning pool 1, ladder section 2, turning pool 2, ladder section 3, turning pool 3, ladder section 4, turning pool 4, ladder section 5, count window, flow control and exit near the navigation lock.

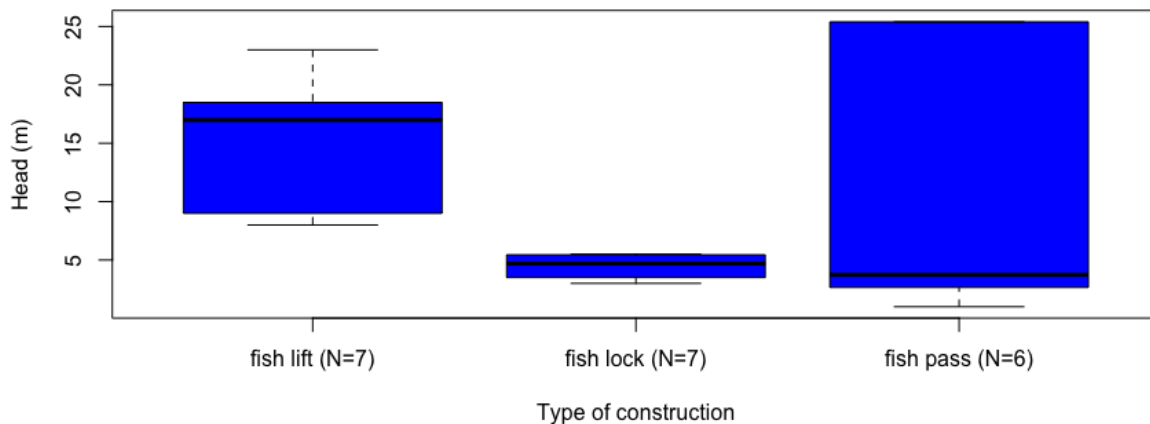
Figure 33: Comparison of fish pass type and head of dam

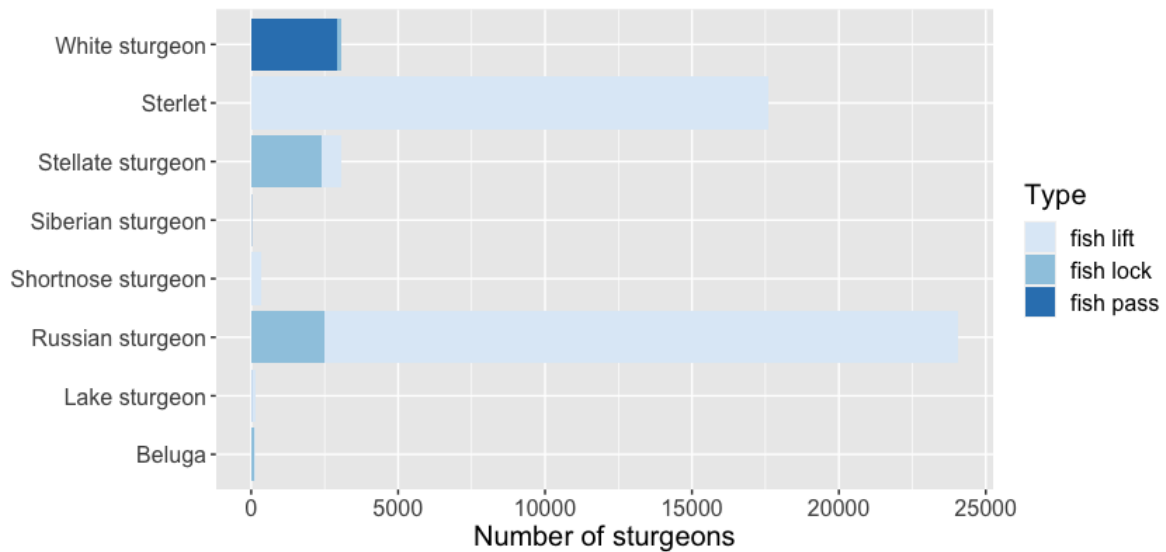
Figure 34: Total number of sturgeons passing dams in case studies analysed according to species and fish pass type

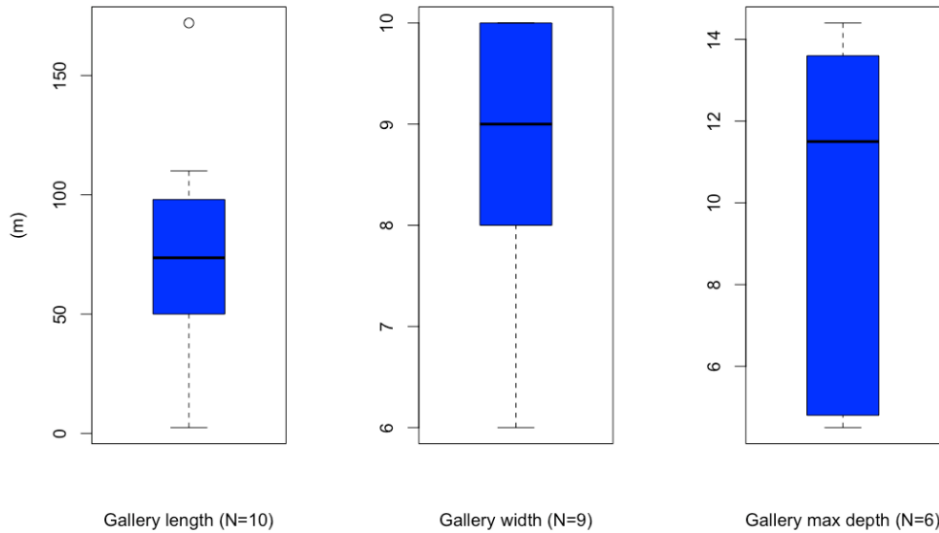
Figure 36: Dimensions of collection galleries at fish lifts and fish locks used by sturgeons

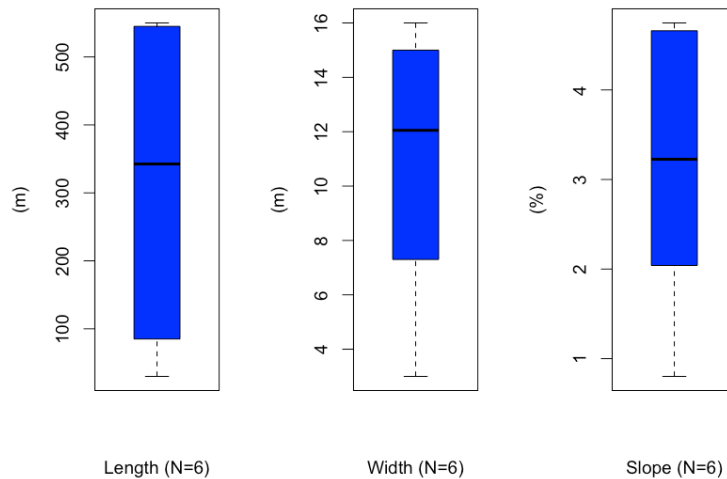
Figure 38: Length, width and slope of conventional fish passes used by sturgeons

Conventional fish passes (pool and weir, fish ramps or nature-like bypass channels) where passage of sturgeons was observed are in general much larger than regular fish passes. The width of pools or channels mostly exceeds 10 m and may range up to 16 m (Figure 38). The length of the fish pass depends on the head of the dam but fish pass slopes are generally lower (1-1.5%) than for salmonid fish passes, with the exception of the Columbia case-study where the pool and weir fish passes are quite steep (4.7%).
